Türk Loydu PSC Newsletter

AUGUST 2024

PSC 02/2024

PSC Detainable Deficiency Alert Condition of Toilets

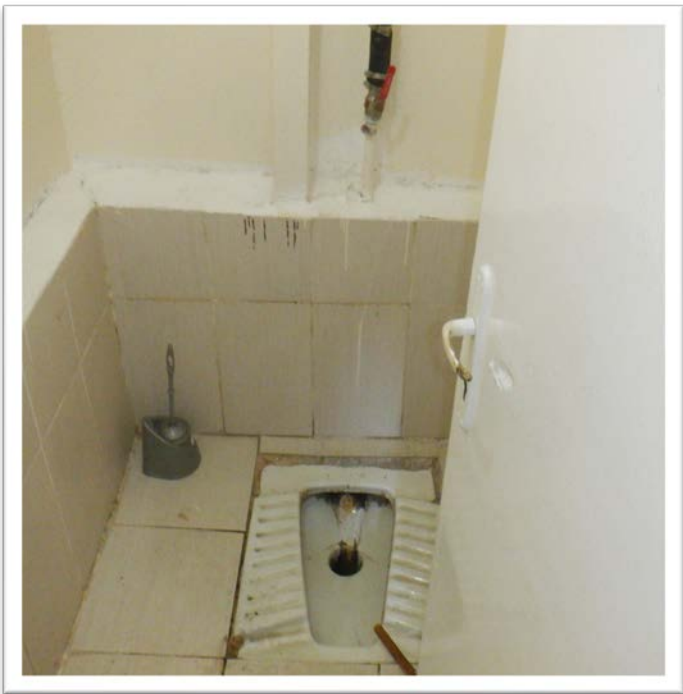
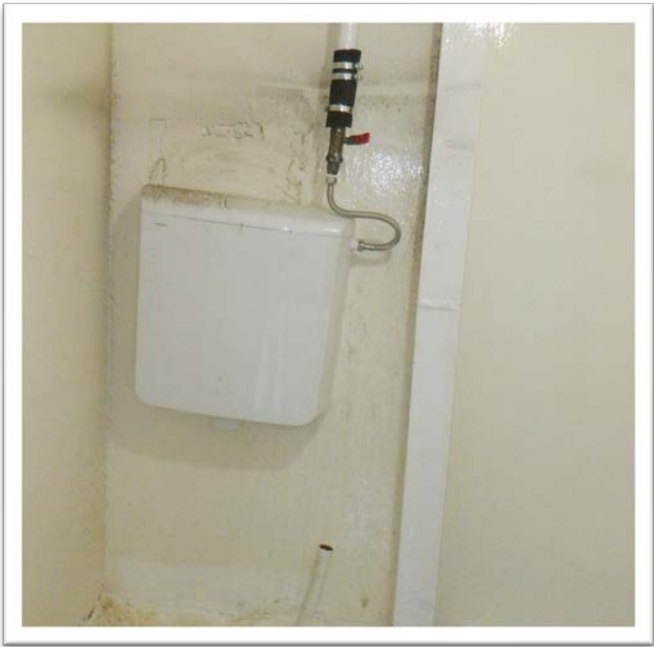
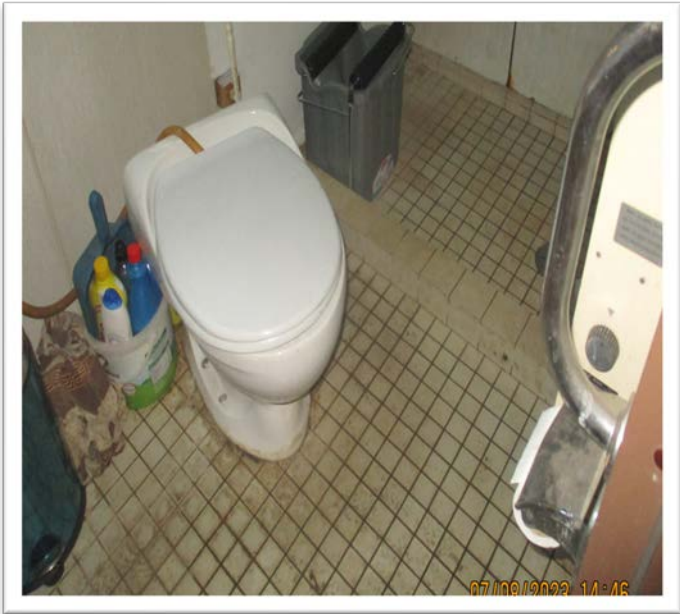
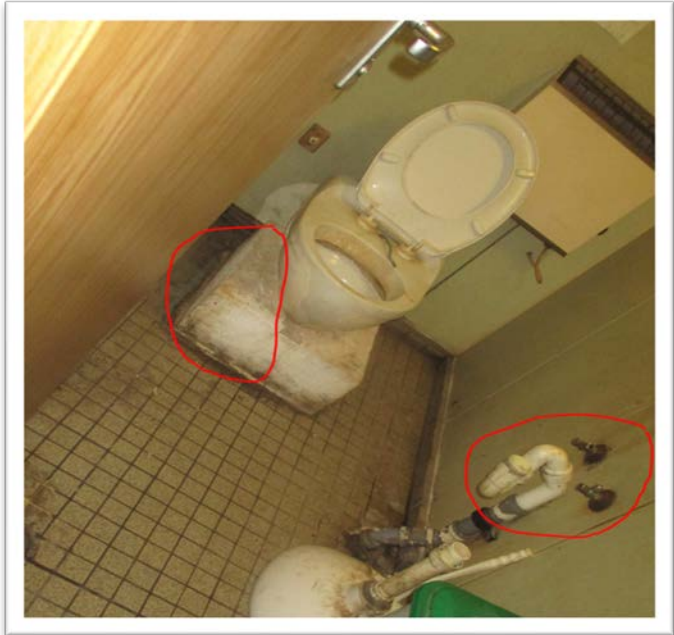
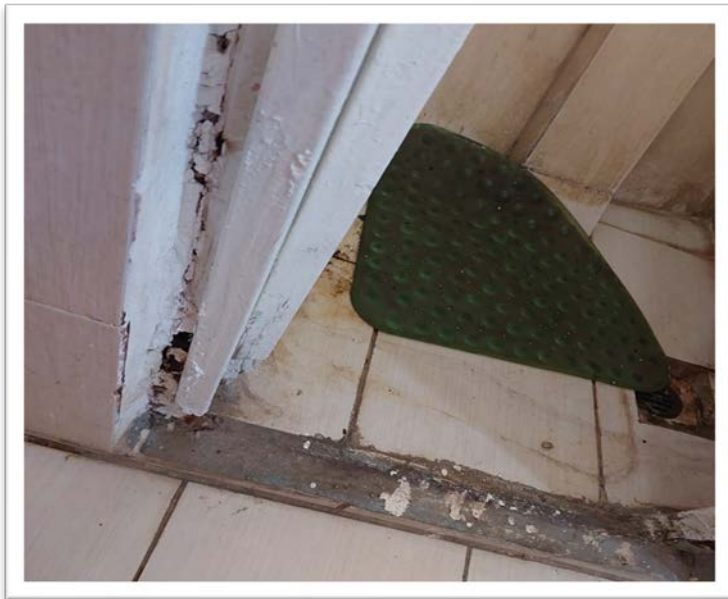
Mou	PSC Place	Group Name	Deficiency
Paris MoU	Gent, Belgium	Labour Conditions	The sink in the toilet room situated on the bridge has no running hot water.
Paris MoU	Constanta, Romania	Labour Conditions	Flushing of the toilet at the main deck was found inoperative, with an outstanding deficiency from PSC Inspection on 24.11.2022.
Paris MoU	Augusta, Italy	Labour Conditions	Toilet flushing water in common toilets on deck 3 is not working and shower blower is damaged, cook toilet is not in hygienic condition. (Ground for Detention)
Paris MoU	Thessaloniki, Greece	Labour Conditions	The flasher at the Bridge Deck toilet was found to be in no working order.
Paris MoU	Constanta, Romania	Labour Conditions	An inappropriate flushing water system was found in the main deck common toilet. (The basins for the flushing water are missing). The sink in the toilet is cracked.
Paris MoU	Constanta, Romania	Structural Conditions	The door to the room where the refrigerators are stored is missing. The frames of the main deck toilet doors were found damaged due to corrosion.

Deficiency Photos That May Lead to Deficiency/Detention

- ❖ Establish a routine maintenance plan for all sanitary facilities.
- ❖ Conduct regular tests on all toilets to ensure the flushing system is working correctly. Resolve any issues with weak or incomplete flushing promptly to prevent blockages, unpleasant smells, and any environmental hazards.

- ❖ Verify that the ship's sewage treatment systems are fully operational.
- ❖ Regularly test all toilets to ensure that pipes, doors, and holding tanks are in good condition and corrosion-free.

- ❖ Repair or replace any corroded components immediately, including door hinges and locks, to prevent leaks, blockages, or malfunctions that could lead to deficiencies during inspections.

- ❖ The hot water supply system in toilet facilities must be functioning properly. Resolve any issues with inconsistent or insufficient hot water without any delay.

- ❖ Ensure all toilet doors are in good working condition by checking that they close properly, locks function correctly, and hinges or frames show no damage or corrosion.

- ❖ Immediately rectify any deficiencies identified during routine checks or reported by crew members. Ensure that corrective actions are carried out and properly documented.

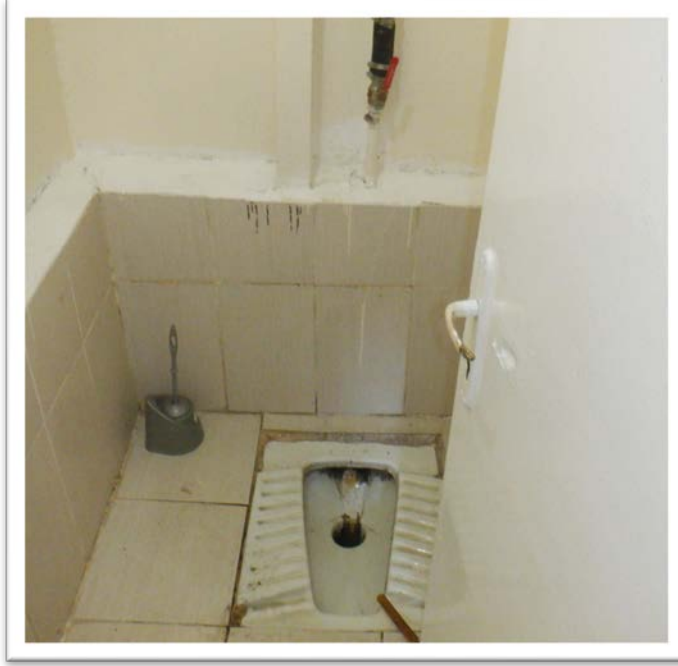
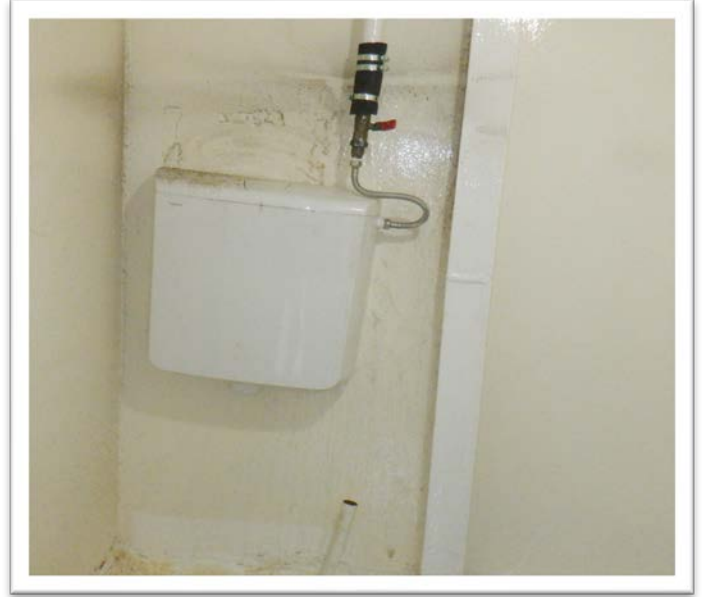
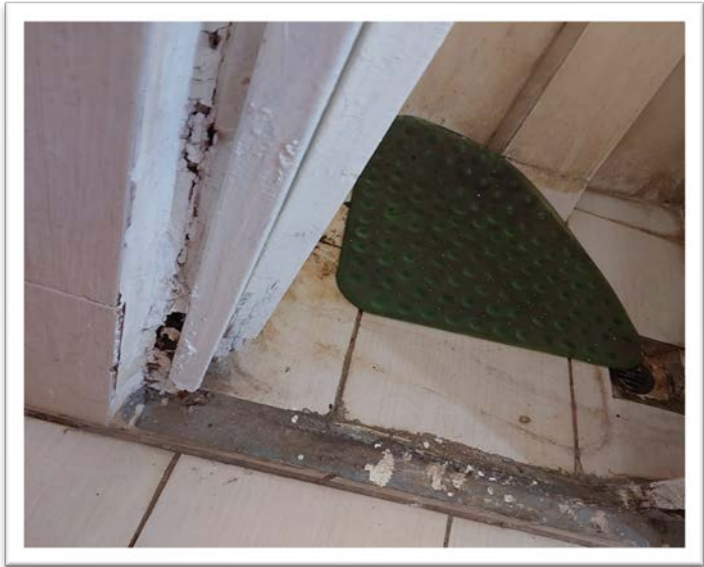
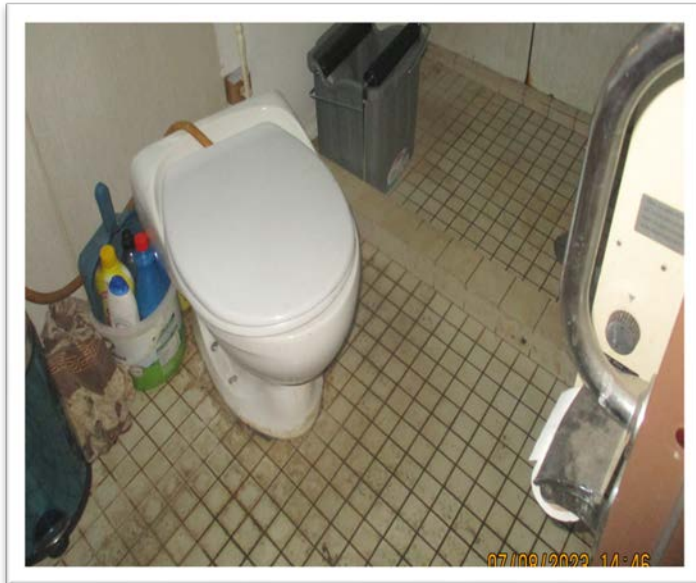
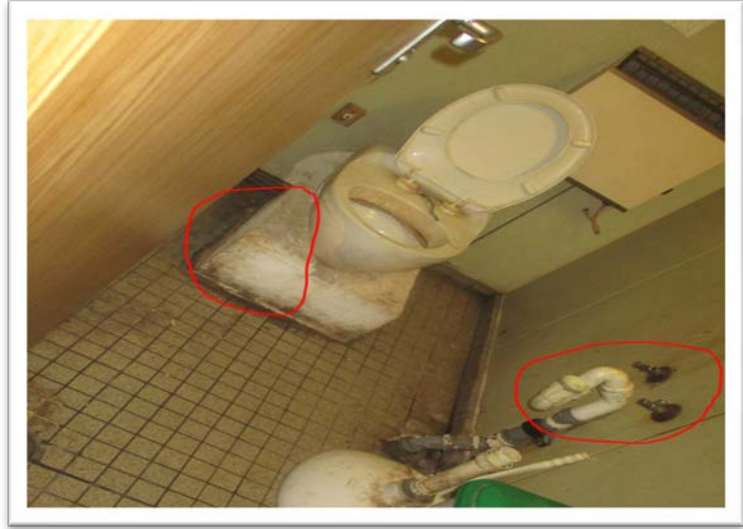
MoU	PSC Yeri	Grup	Uygunsuzluk
Paris MoU	Gent, Belgium	Çalışma Koşulları	Köprüüstünde bulunan tuvalette yer alan lavabodan sıcak su akmamaktadır.
Paris MoU	Constanta, Romania	Çalışma Koşulları	24.11.2022 tarihinde PSC denetiminde tespit edilen ve uygunsuzluk olarak kaydedilen ana güvertedeki tuvaletin sifonunun çalışmaması durumu tekrar gözlemlenmiştir.
Paris MoU	Augusta, Italy	Çalışma Koşulları	Ortak tuvaletteki sifon çalışmıyor, duş havalandırması hasarlı, aşçı kamerasında yer alan tuvalet hijyenik değil. (Tutuklanma sebebi)
Paris MoU	Thessaloniki, Greece	Çalışma Koşulları	Köprüüstü tuvaletinin sifonu çalışmamaktadır.
Paris MoU	Constanta, Romania	Çalışma Koşulları	Ana güvertede yer alan tuvalette uygunsuz bir sifon sistemi tespit edilmiştir. Ayrıca tuvaletteki lavabo çatlamış durumdadır.
Paris MoU	Constanta, Romania	Yapısal Durum	Ana güvertedeki tuvalet kapılarının çerçevelerinin korozyon nedeniyle hasar gördüğü tespit edilmiştir.

Uygunsuzluk / Tutuklama Sebebi Olabilecek Fotoğraflar

- ❖ Tüm tuvalet tesisleri (klozet, lavabo, duş,vb.) için düzenli bir bakım planı oluşturulmalıdır.
- ❖ Tüm tuvaletlerde düzenli testler yaparak sifon sisteminin doğru çalıştığından emin olunmalı. zayıf sifon sorunları hemen çözülerek tıkanmalar, kötü kokular ve çevresel tehlikeler önlenmelidir.

- ❖ Gemi atık su arıtma sistemlerinin tamamen çalışır durumda olduğundan emin olunmalıdır.
- ❖ Tüm tuvaletler düzenli olarak test edilmeli ve boruların, kapıların ve depolama tanklarının iyi durumda ve korozyonsuz olduğundan emin olunmalıdır.

- ❖ Korozyona uğramış tüm bileşenler, kapı menteşeleri ve kilitler dahil olmak üzere, hemen onarılmalı ve değiştirilmelidir.
- ❖ Tuvalet tesislerindeki sıcak su sistemi düzgün çalışmalıdır. Sıcak suyun tutarsız veya yetersiz olmasıyla ilgili sorunlar gecikmeden çözülmelidir.

- ❖ Tüm tuvalet kapılarının iyi çalıştığından emin olunmalıdır. Kapıların düzgün kapandığını, kilitlerin doğru çalıştığını ve menteşe veya çerçevelerde hasar veya korozyon bulunmadığı kontrol edilmelidir.

- ❖ Rutin kontroller sırasında tespit edilen veya mürettebat üyeleri tarafından bildirilen eksiklikler hemen düzeltilmelidir. Düzeltici önlemlerin alındığından ve uygun şekilde belgelendiğinden emin olunmalıdır.
