# TÜRK LOYDU

## **Guideline on Türk Loydu Hull Inspection and Maintenance Program-Grading for Findings During Inspections**

**2013**

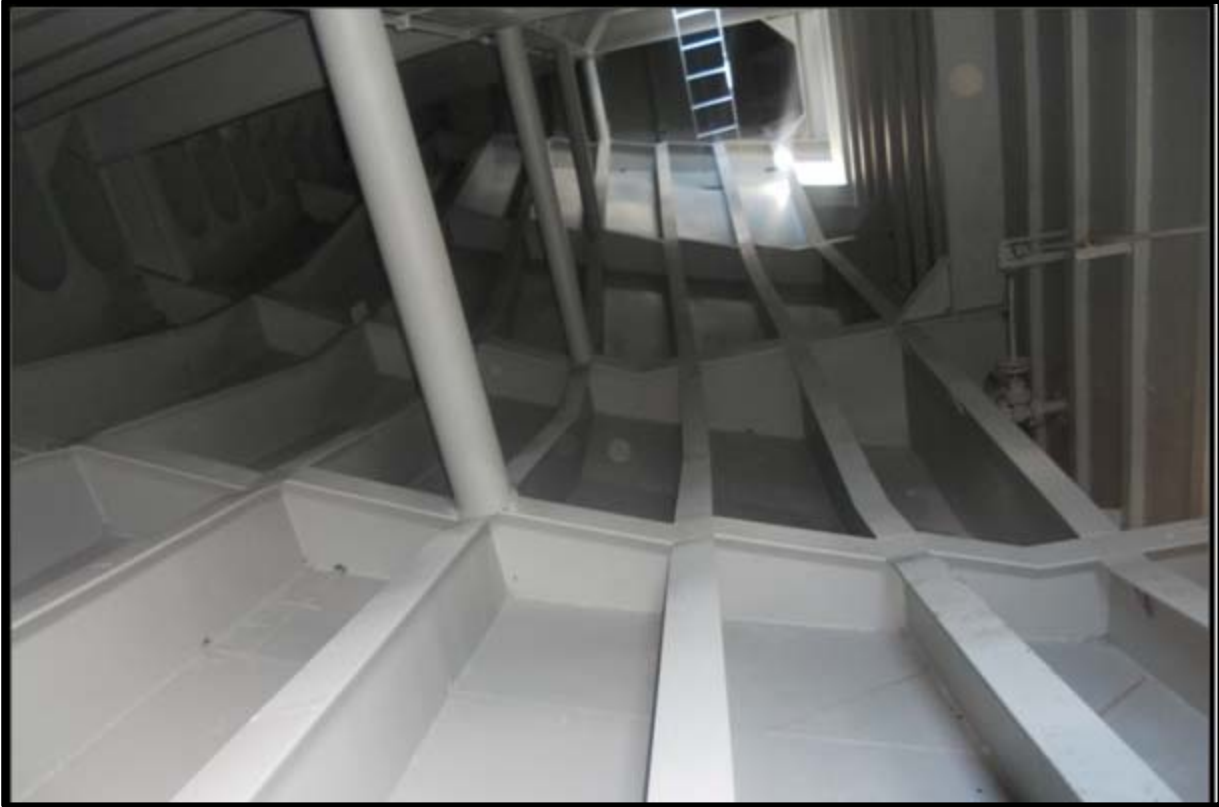
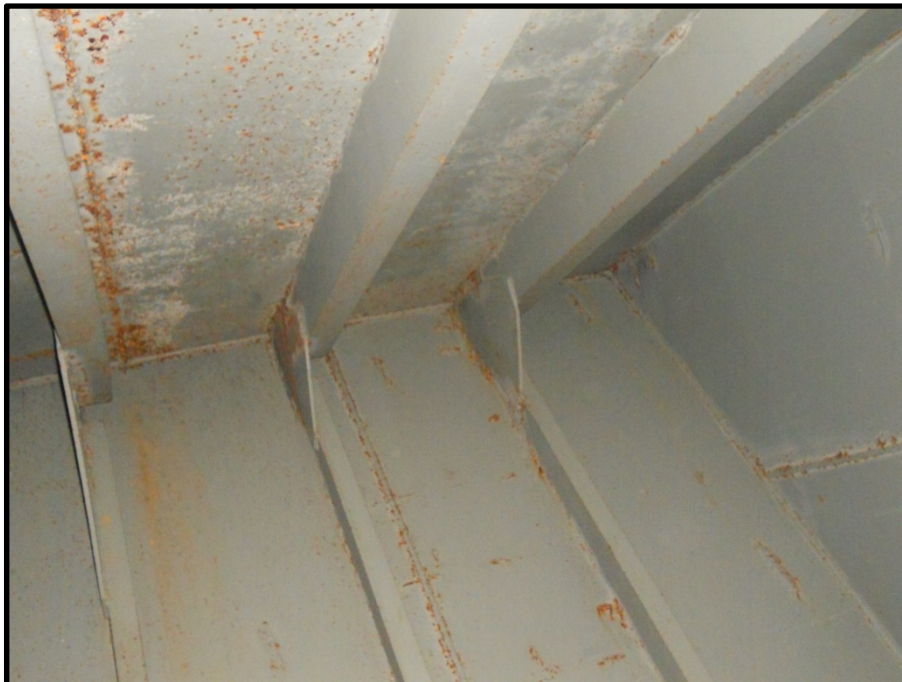
**Figure 3. Coating Condition-Good**

Newly coated,no major coating breakdown

Minor spor rusting

GOOD condition with only minor spot rusting

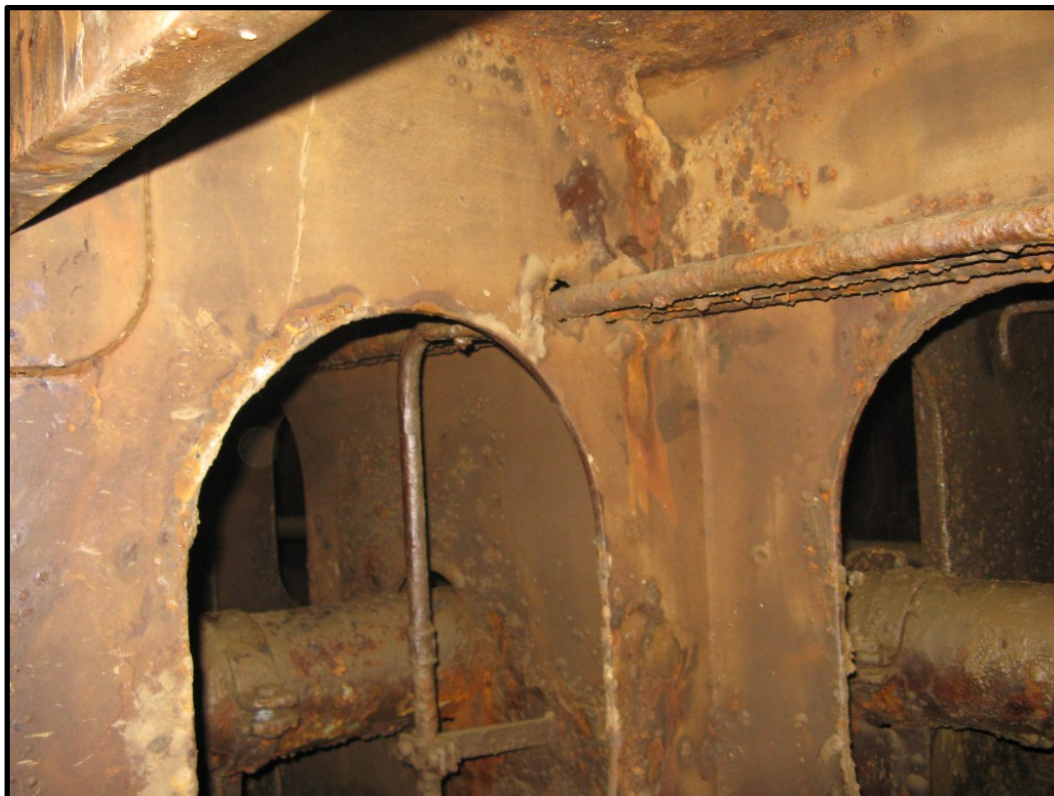
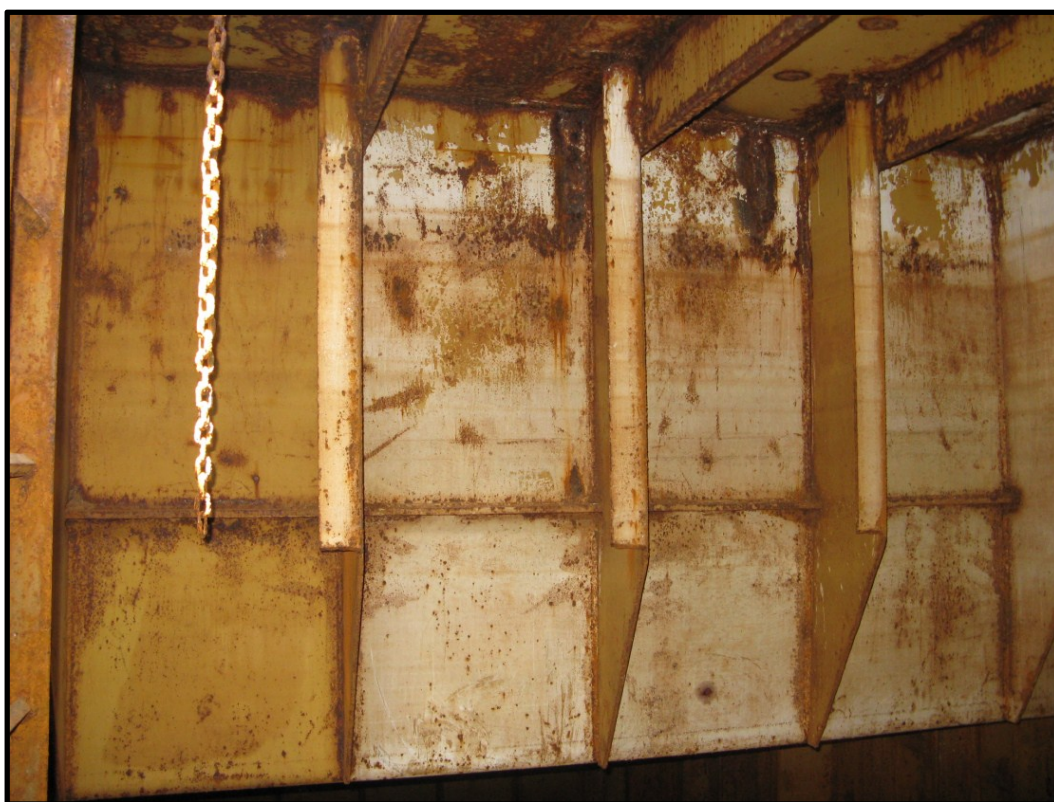
**Figure 4. Coating Condition-Fair**

With local breakdown at edges of stiffeners and weld connections light rusting over 20% or more of areas under consideration, but less than as defined for POOR condition

FAIR condition with local breakdown at edges of stiffeners and weld connections light rusting over 20% or more of areas under consideration, but less than as defined for POOR condition

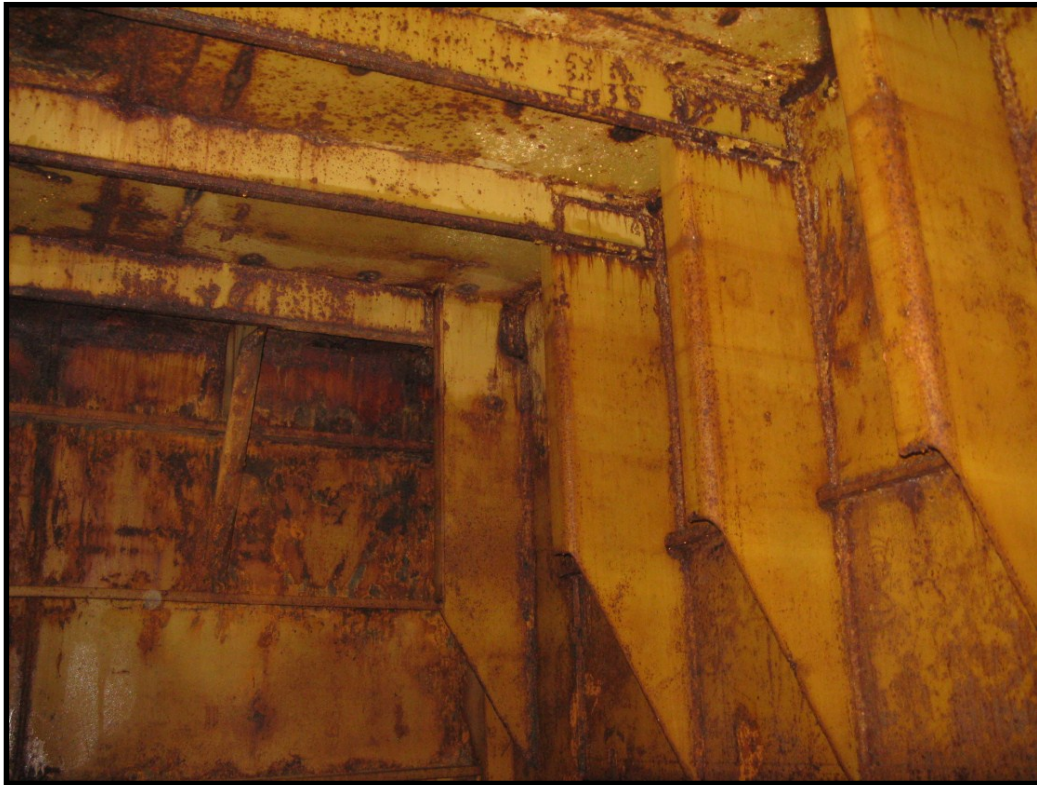
Figure 5. Coating Condition-Poor

With general breakdown of coating over 20% or more of areas or hard scale at 10% or more of areas under consideration

POOR condition with general breakdown of coating over 20% or more of areas or hard scale at 10% or more of areas under consideration

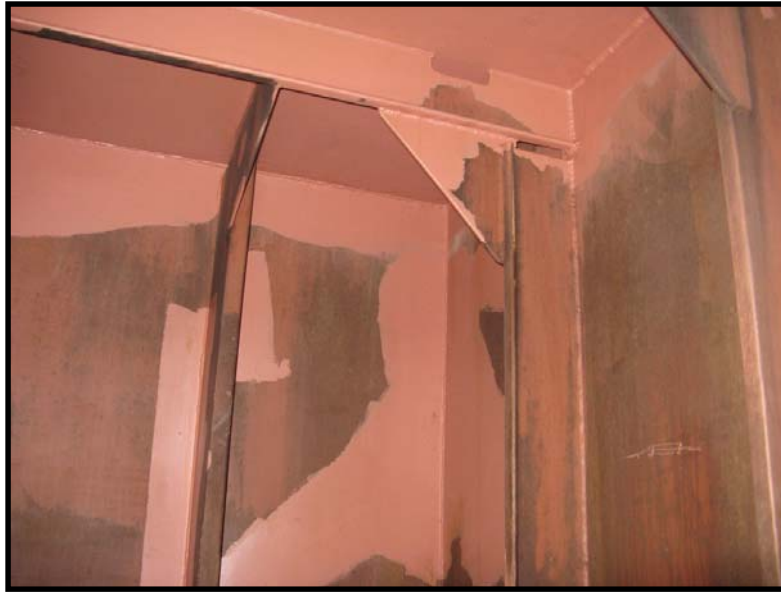
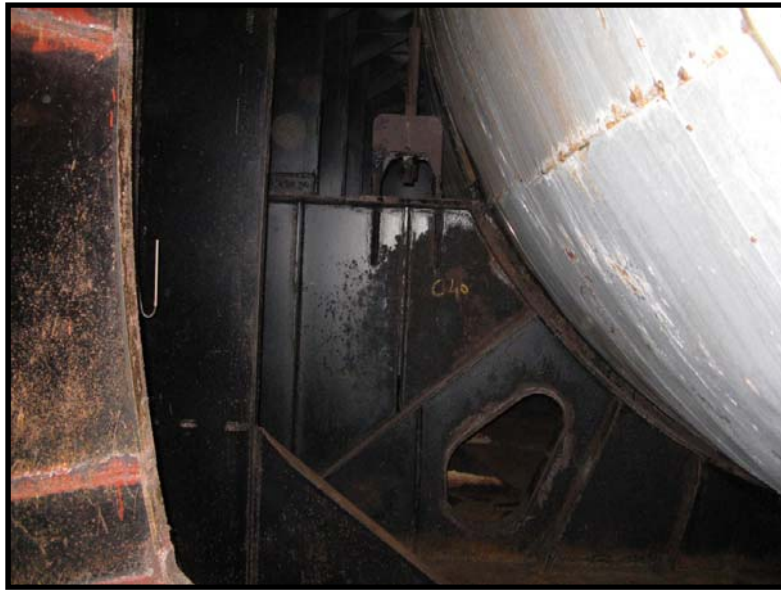
**Figure 8. General Corrosion-Good Condition**

Spaces with no rusting to minor spot rusting are counted as GOOD- light rust shall not be more than 20% of the total area

Spaces with no rusting to minor spot rusting are counted as GOOD- light rust shall not be more than 20% of the total area.

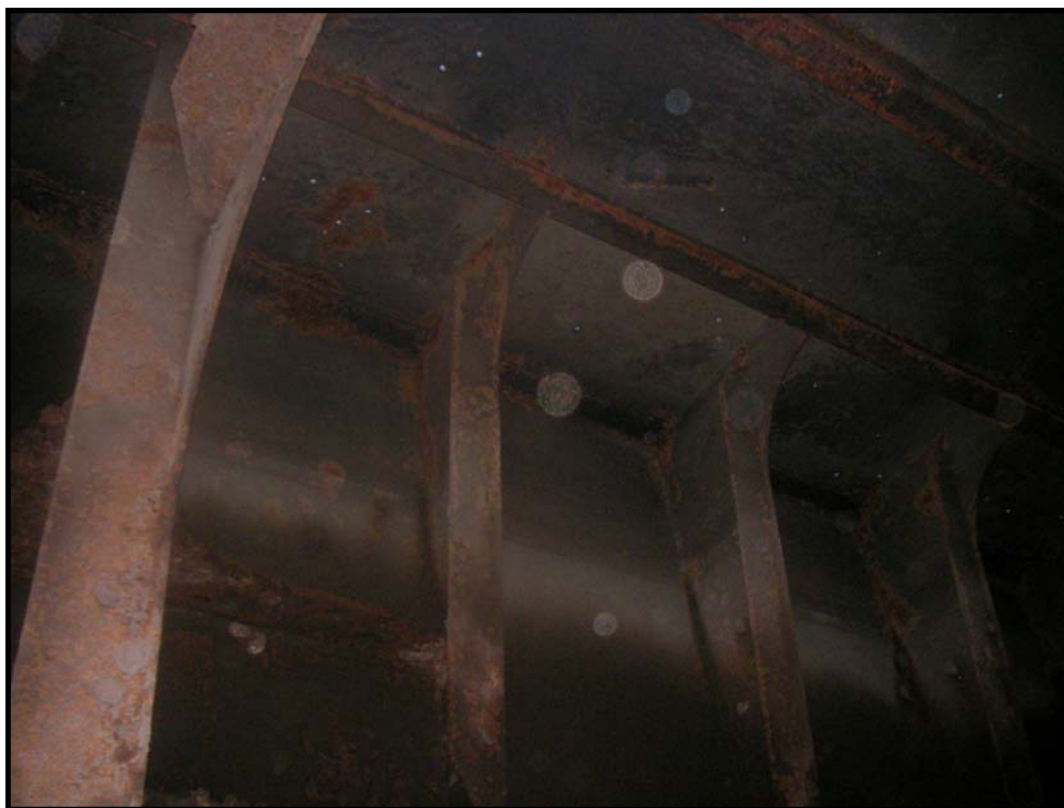
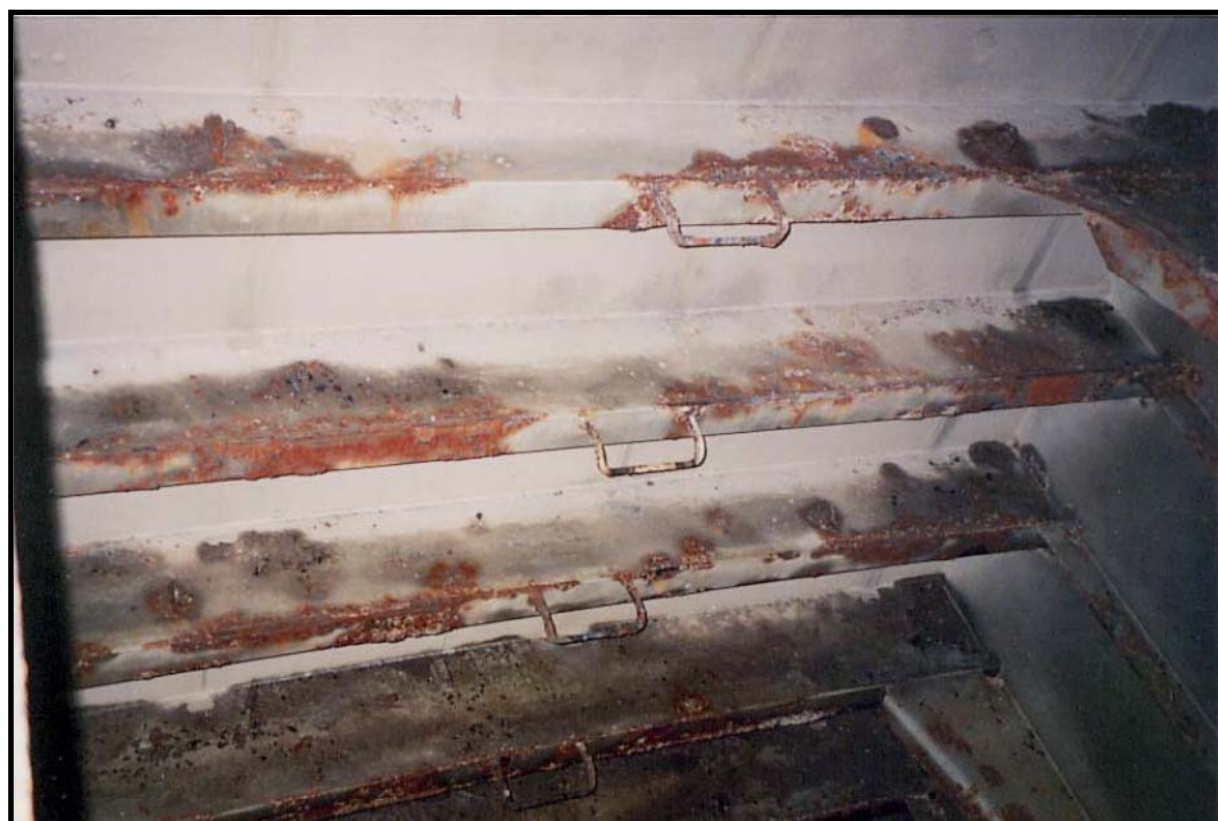
**Figure 9. General Corrosion-Fair Condition**

Spaces with more than 20% light rust and upto 30% hard scale rust are counted as FAIR

Spaces with more than 20% light rust and up to 30% hard scale rust are counted as FAIR.

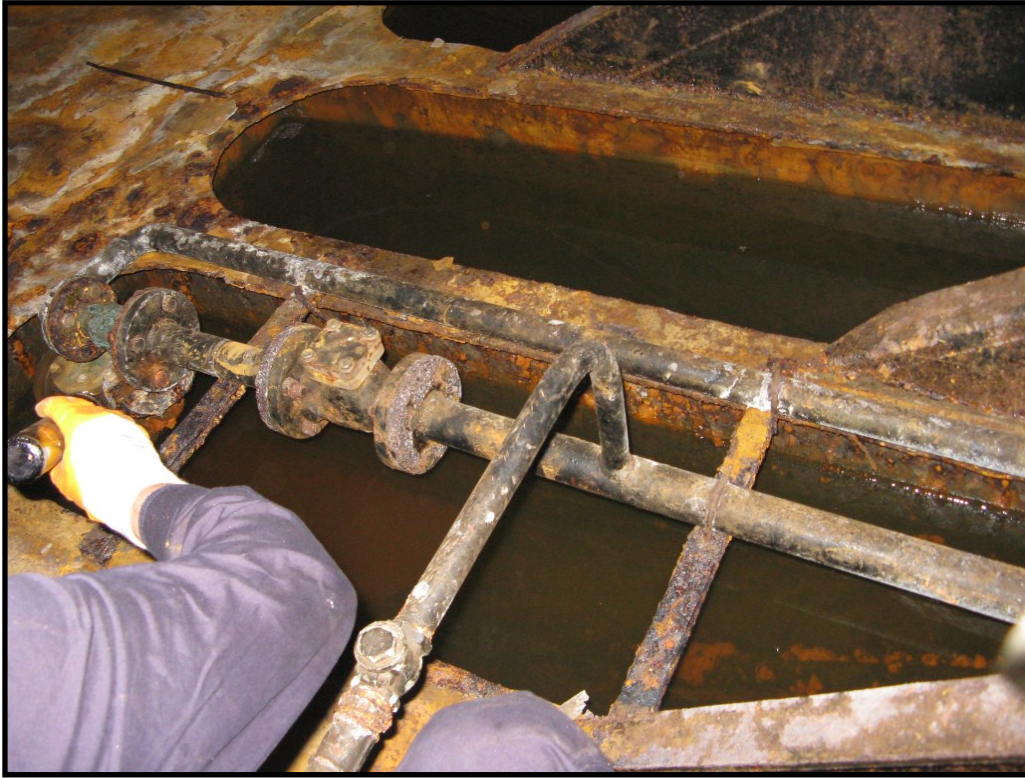
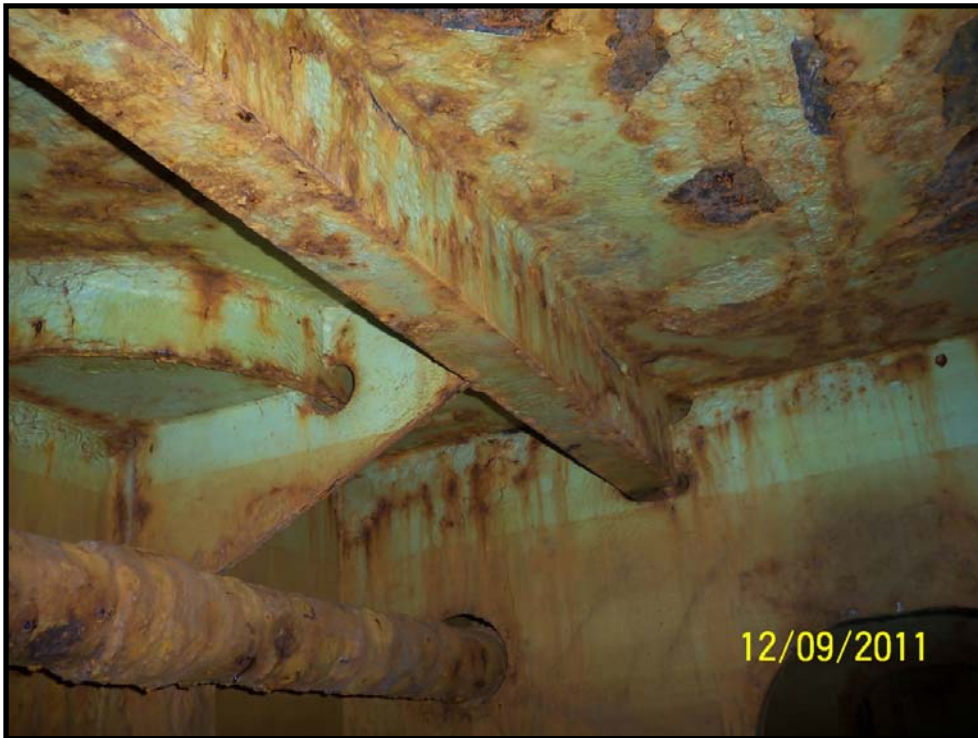
**Figure 10. General Corrosion-Poor Condition**

Spaces with more than 30% hard scale are counted as POOR- Active scale is loose or tends to fall off the structure surface

Spaces with more than 30% hard scale are counted as POOR- Active scale is loose or tends to fall off the structure surface.

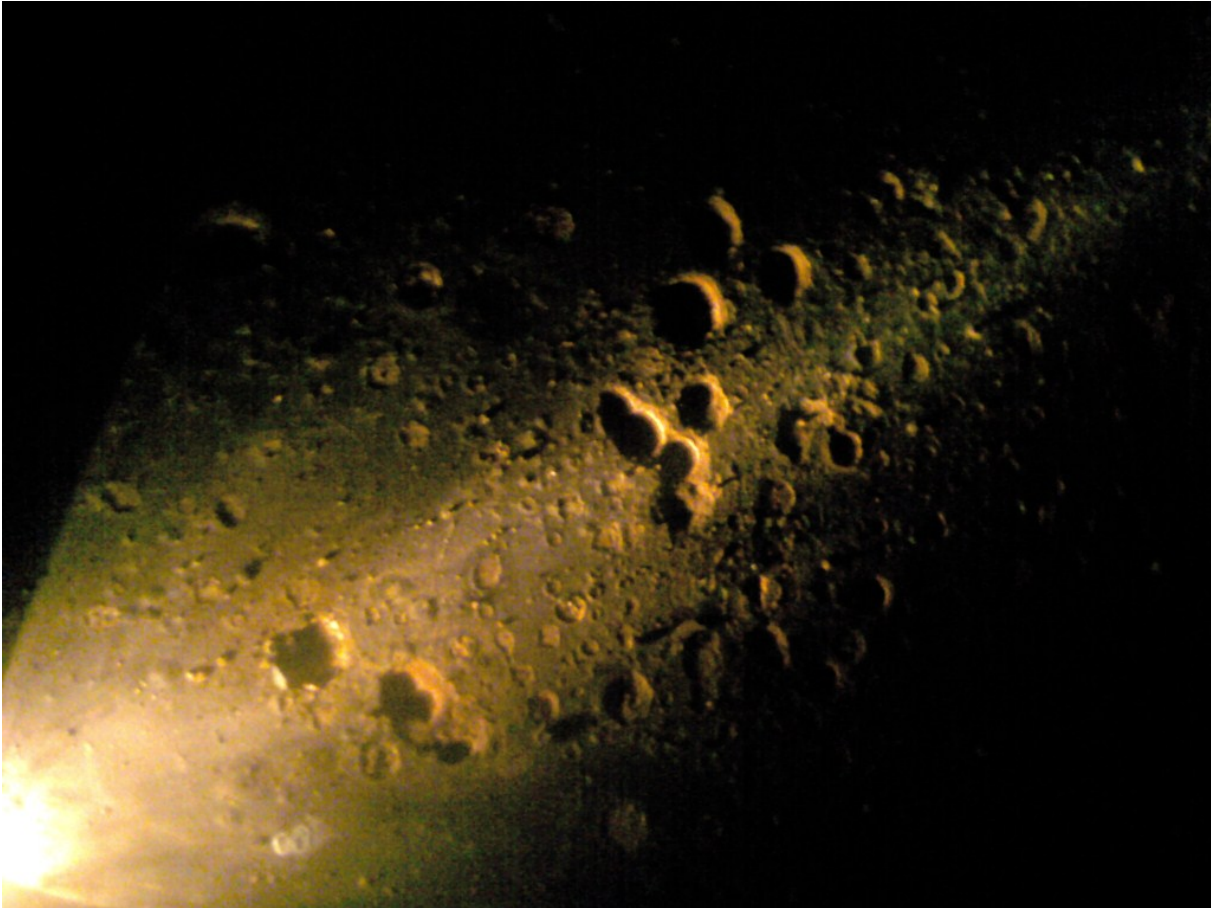
**Figure 11. Pittings on Bottom Plating Inside A Ballast Tank**

Pitting corrosion is a commonly encountered type of corrosion, that can be noted, especially in ballast tanks, where water is trapped or the flow of water is followed. Horizontal surfaces, such as bottom plating, are locations, where deep pitting can occur. Pittings on coated surfaces are commonly in small diameters, but deep. Attack of the pitting corrosion can result as holes on shell plating. On uncoated surfaces, the pittings are shallow, but wide, so it resembles the condition of general corrosion.

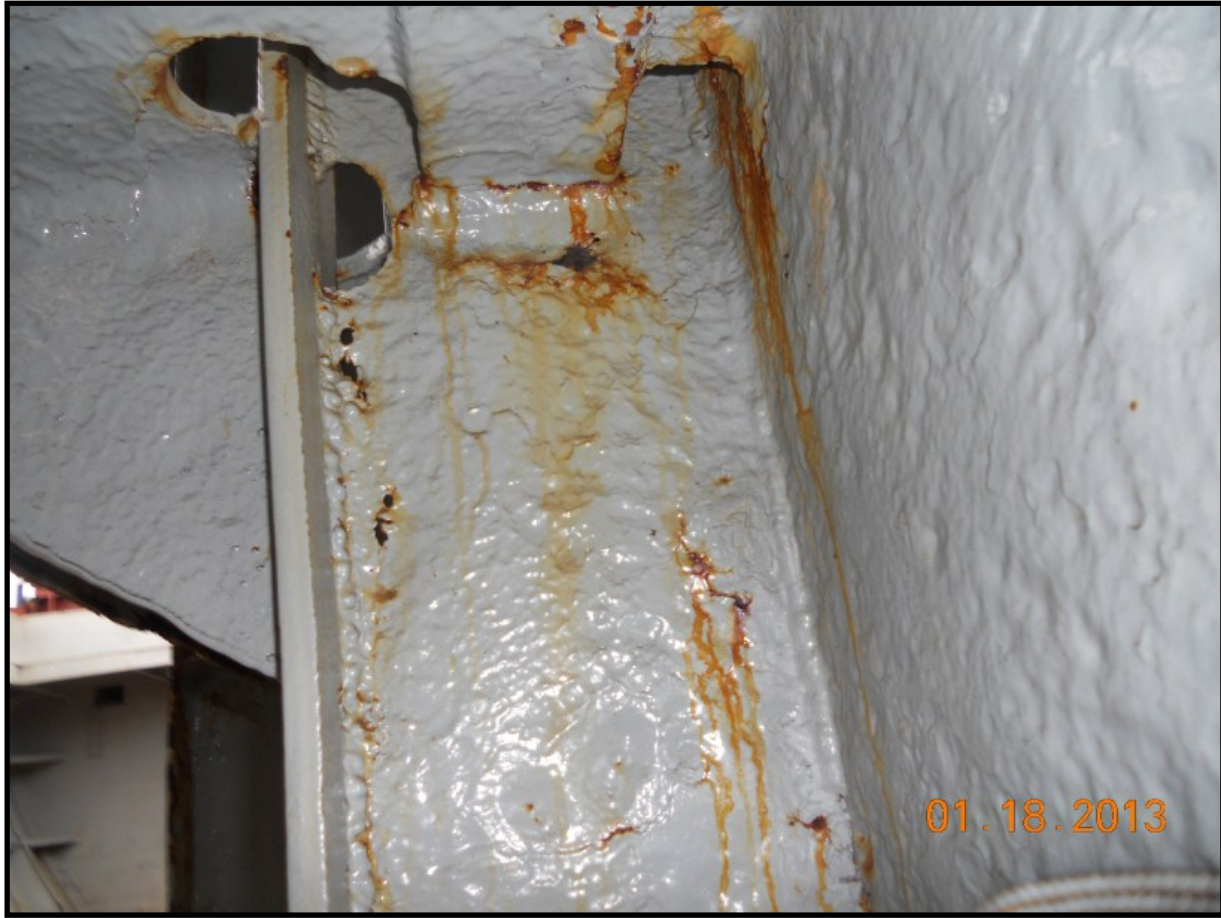
**Figure 12. Holes on A Vertical Shell Plating Member Caused By Groove Corrosion**

Grooving corrosion is a localized and linear corrosion, which occurs at welds or heat affected zones along abutting stiffeners, and at stiffener or plate butts or seams. Extensive groove corrosion causes the structural member to rupture from the attached structure in due course, causing also secondary problems for the attached structure, such as panel plating.

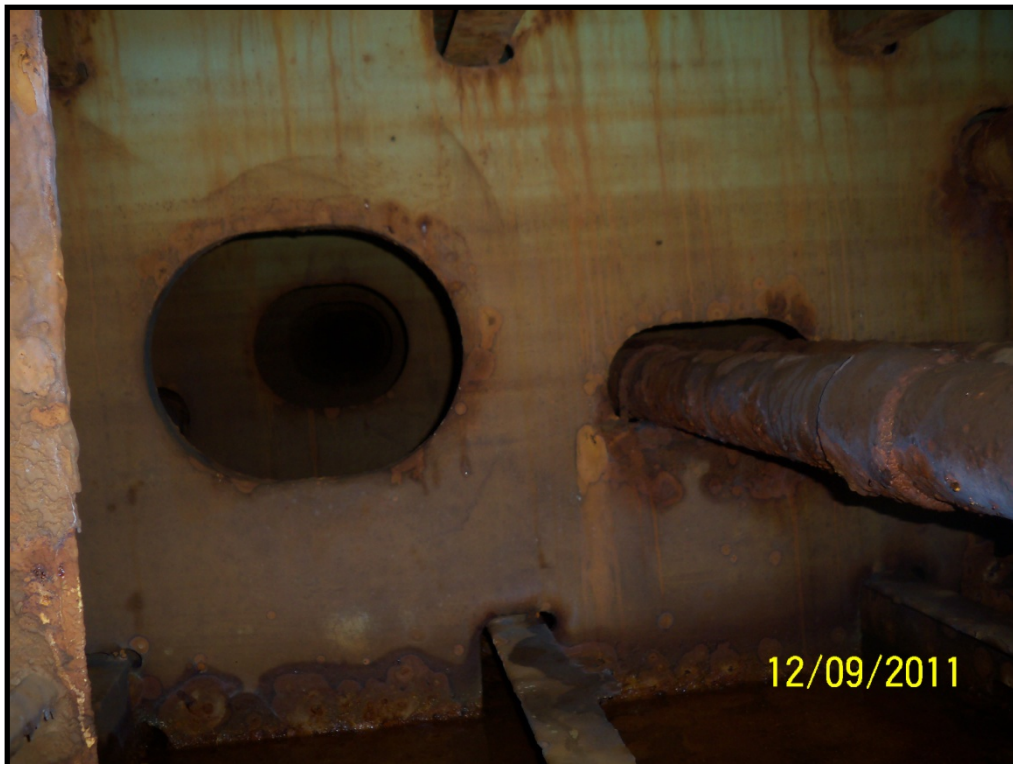
**Figure 13. Pitting and Groove-Good Condition**

Shallow pits/grooves with depth less than 1/3 of the original thickness and with intensity less than 15% of the zone are considered as GOOD.

Shallow pits/grooves with depth less than 1/3 of the original thickness and with intensity less than 15% of the zone are considered as GOOD.

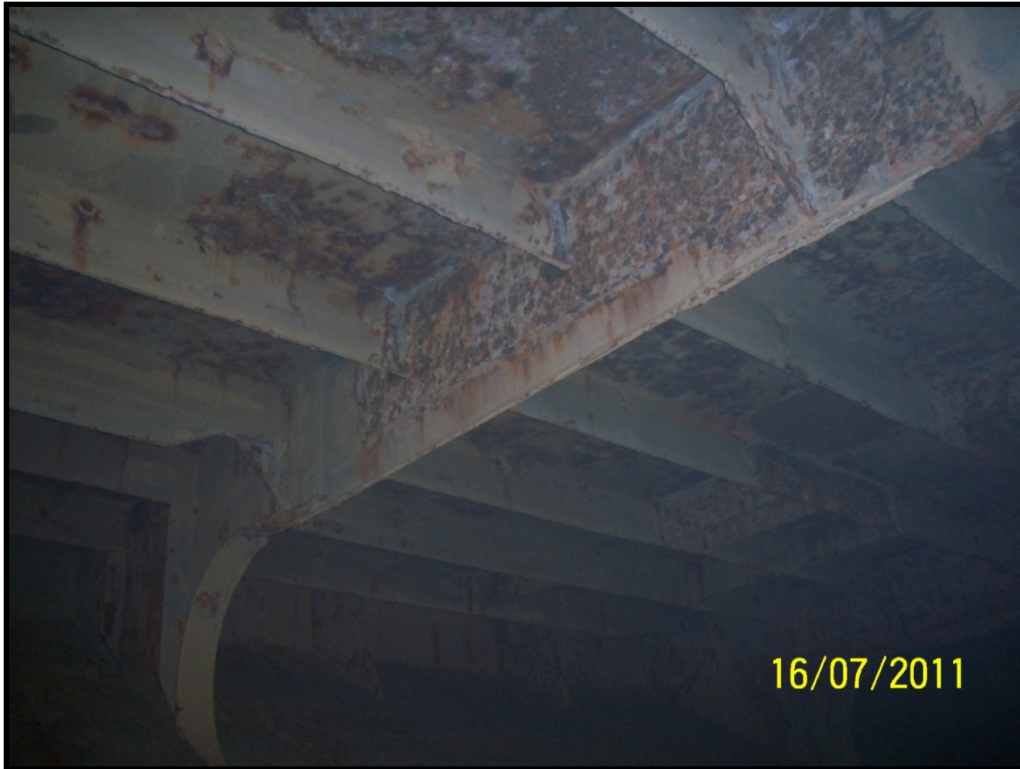
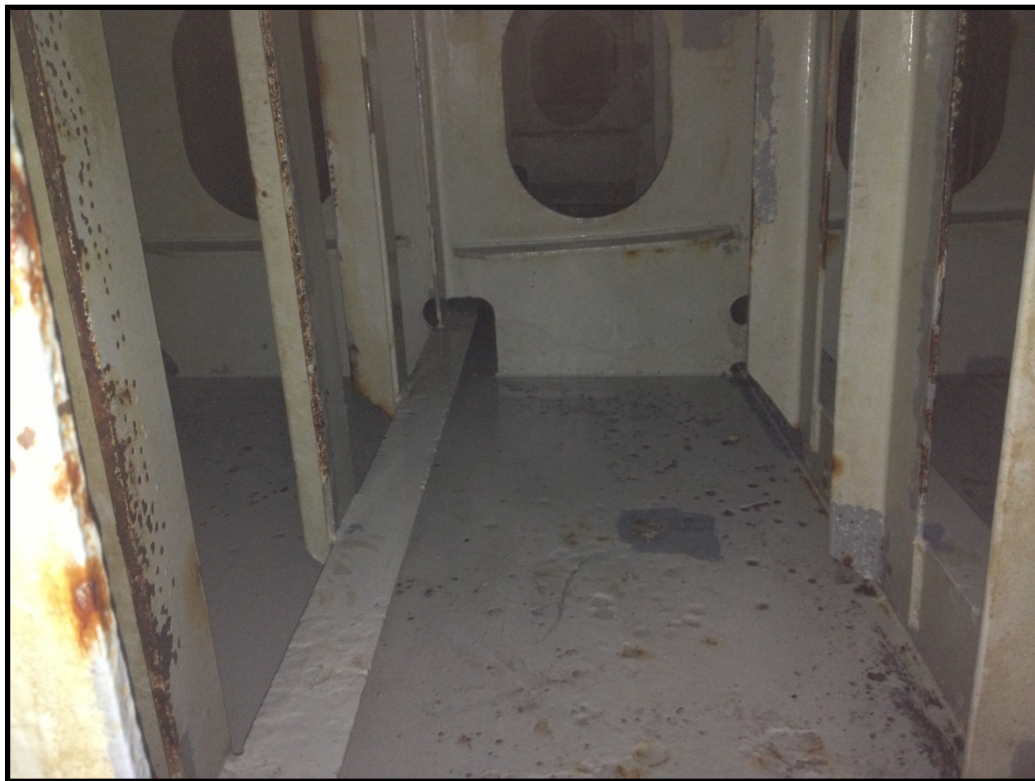
**Figure 14. Pitting and Groove-Fair Condition**

Shallow pits with intensity of more than 15%, depth less than 1/3 of the original thickness

Deep pits with more than 1/3 of the original thickness, intensity less than 15%

Shallow pits/grooves with depth less than 1/3 of the original thickness and with intensity more than 15% of the zone.

Deep pits with depth more than 1/3 of the original thickness and with intensity less than 15% of the zone are considered as FAIR.

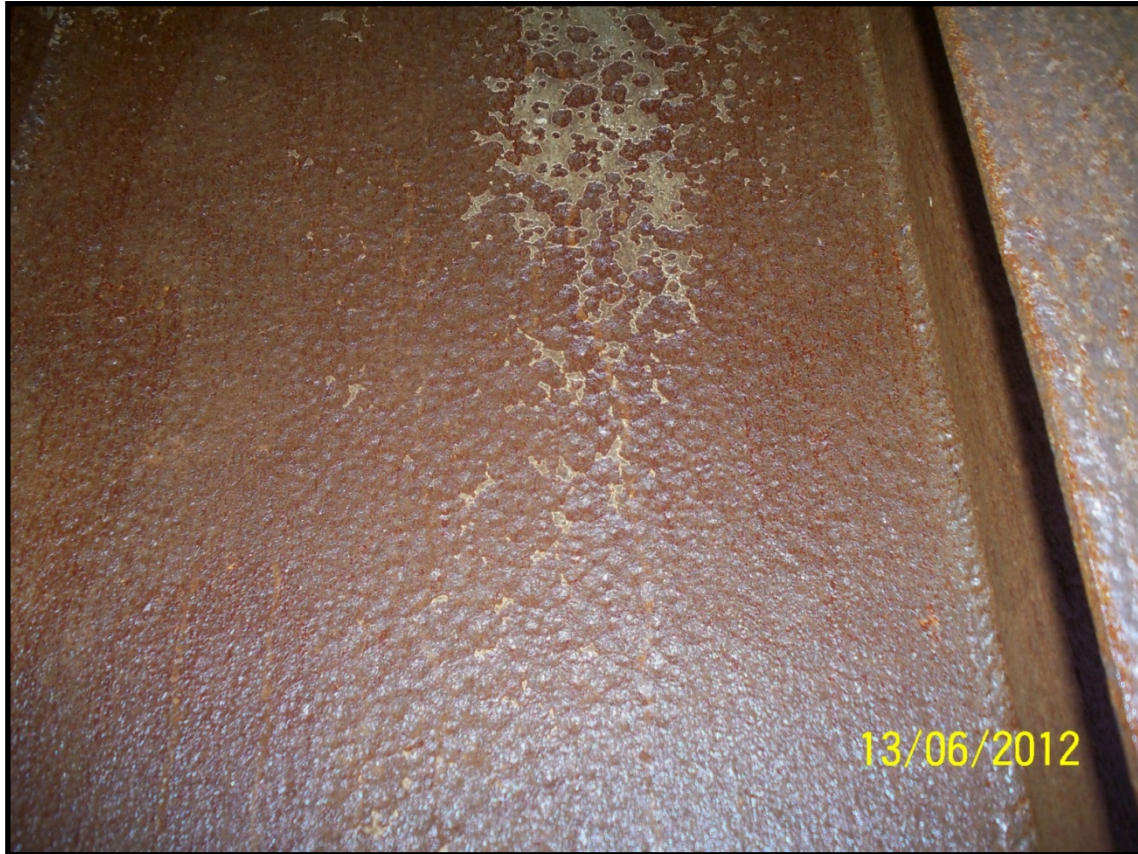
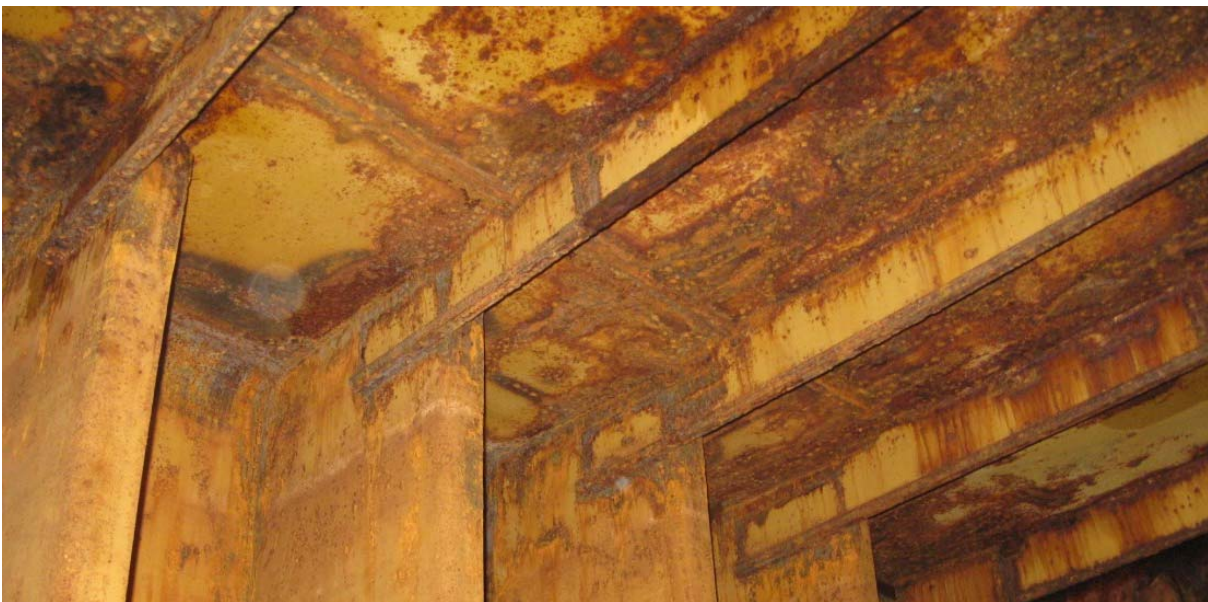
**Figure 15. Pitting and Groove-Poor Condition**

Pits covering a large surface causing a total diminution of the plating over the limits as defined by society's rules

Deep pits/grooves, where the remaining thickness of the zone is less than 6mm, regardless of the intensity, are considered as POOR

Deep pits/grooves, where the remaining thickness of the zone is less than 6mm, regardless of the intensity, are considered as POOR.

**If pits/grooves cover a large surface, the maximum allowable diminutions for the applicable area is to be considered in order to evaluate the condition.**

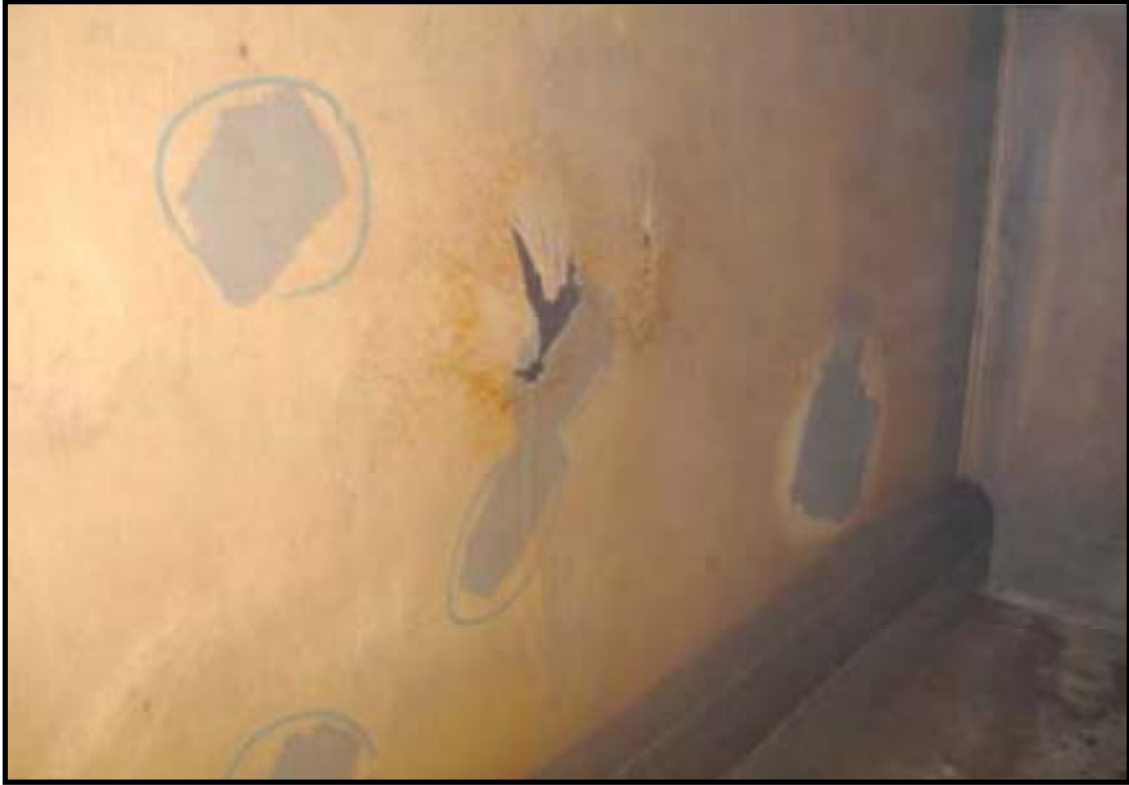
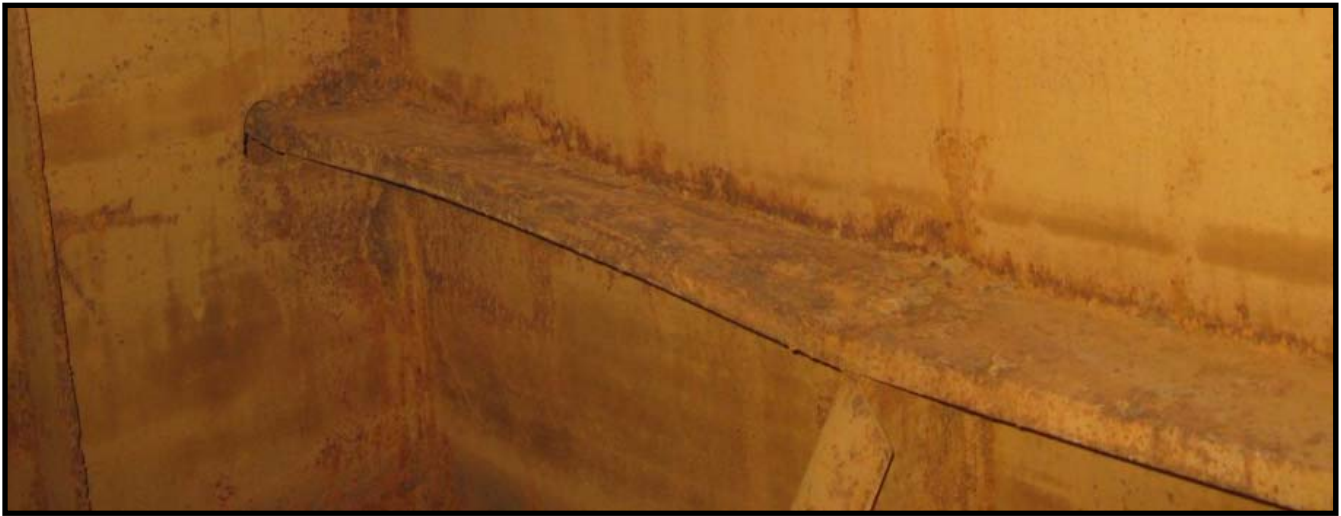
**Figure 16. Deformation-Good Condition**

Deformations within the panel are generally accepted, the set-in depth is generally considered as not more than 5 times the thickness of the original panel plating-such deformations may be considered as GOOD.

Deformations within the panel are generally accepted, the set-in depth is generally considered as not more than 5 times the thickness of the original panel plating-such deformations may be considered as GOOD.

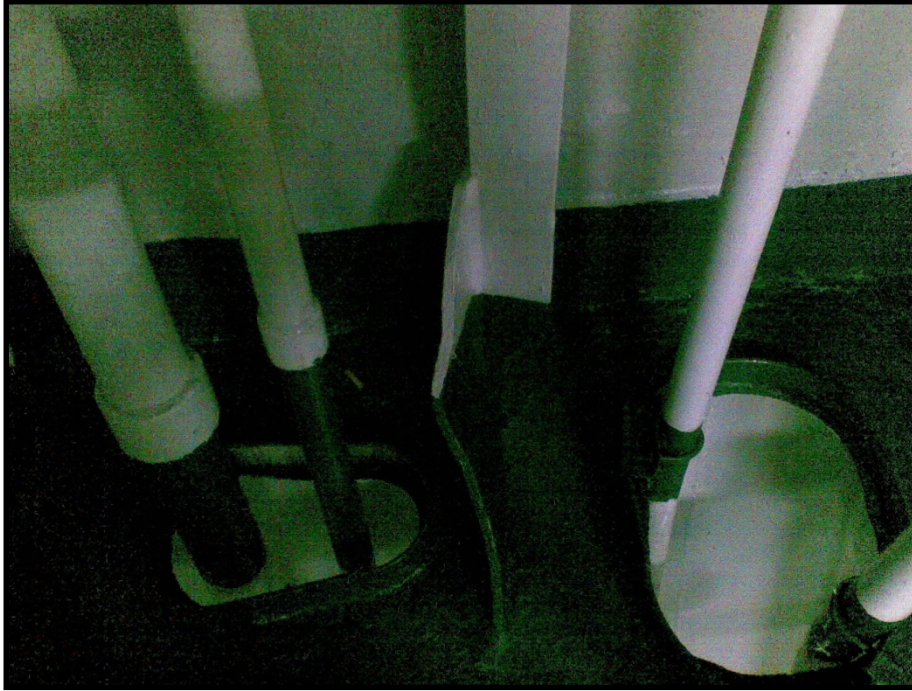
**Figure 17. Deformation-Fair Condition**

Tripped/buckled internals

Deformations within the bay, together with the associated internals, where the set-in depth is not more than 5 times the thickness of the original plating, may be considered as FAIR.

Tripped brackets&internals may also be considered as FAIR.

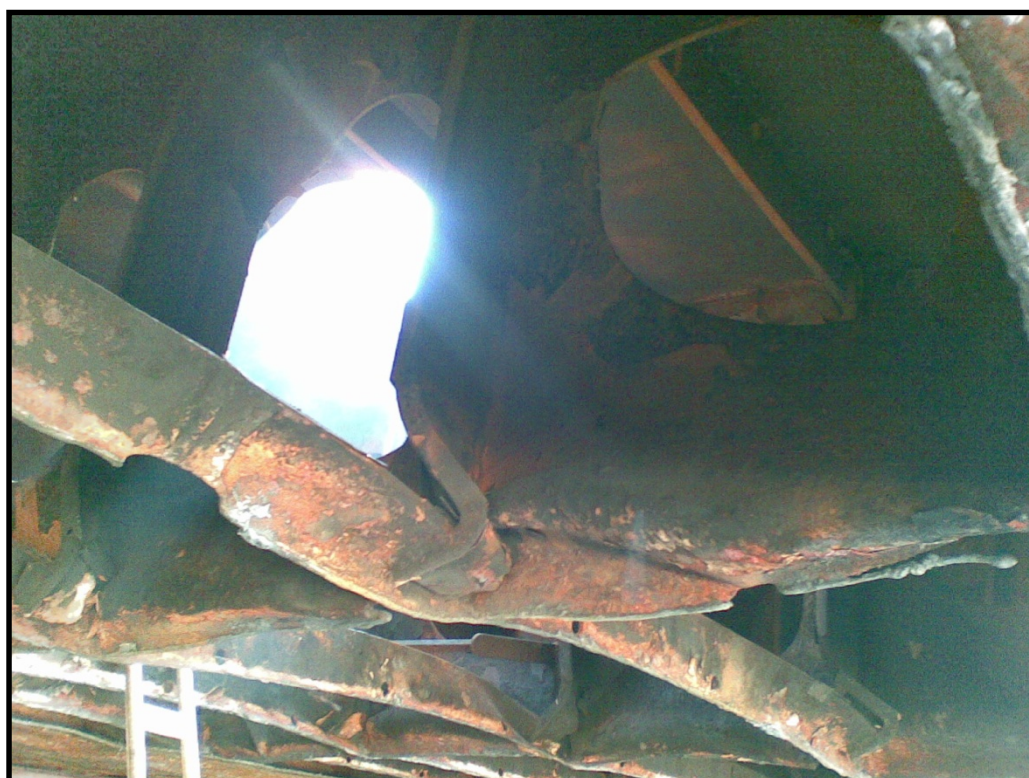
**Figure 18. Deformation-Poor Condition**

Deformation within bay-buckled/indented internals

Multiple bays-deformed/tripped internals

Deformations within bay, with buckled-indent-ed-tripped internals, where the set-in depth is less than 5 times the original thickness of the associated structures may be considered as POOR.

Deformations within multiple bays with buckled-indent-ed-tripped internals are also considered as POOR.

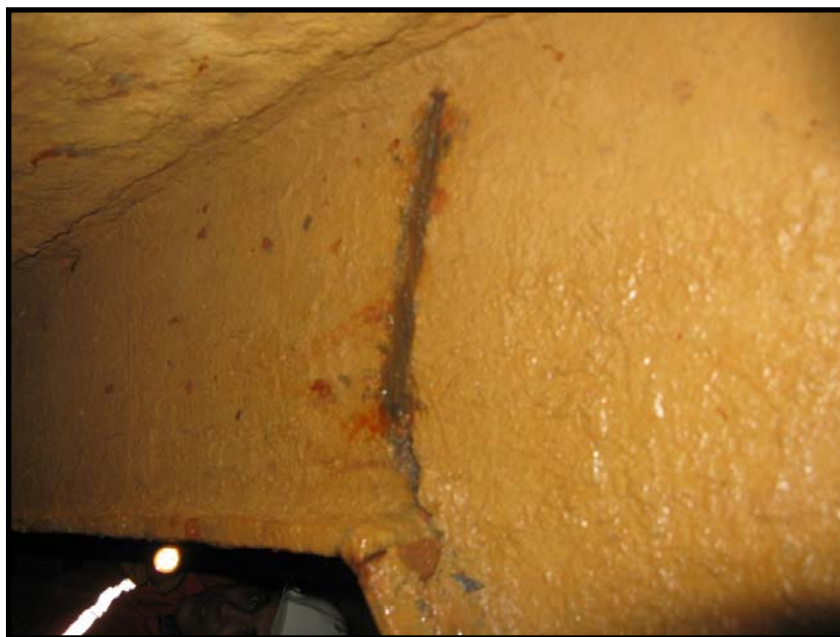
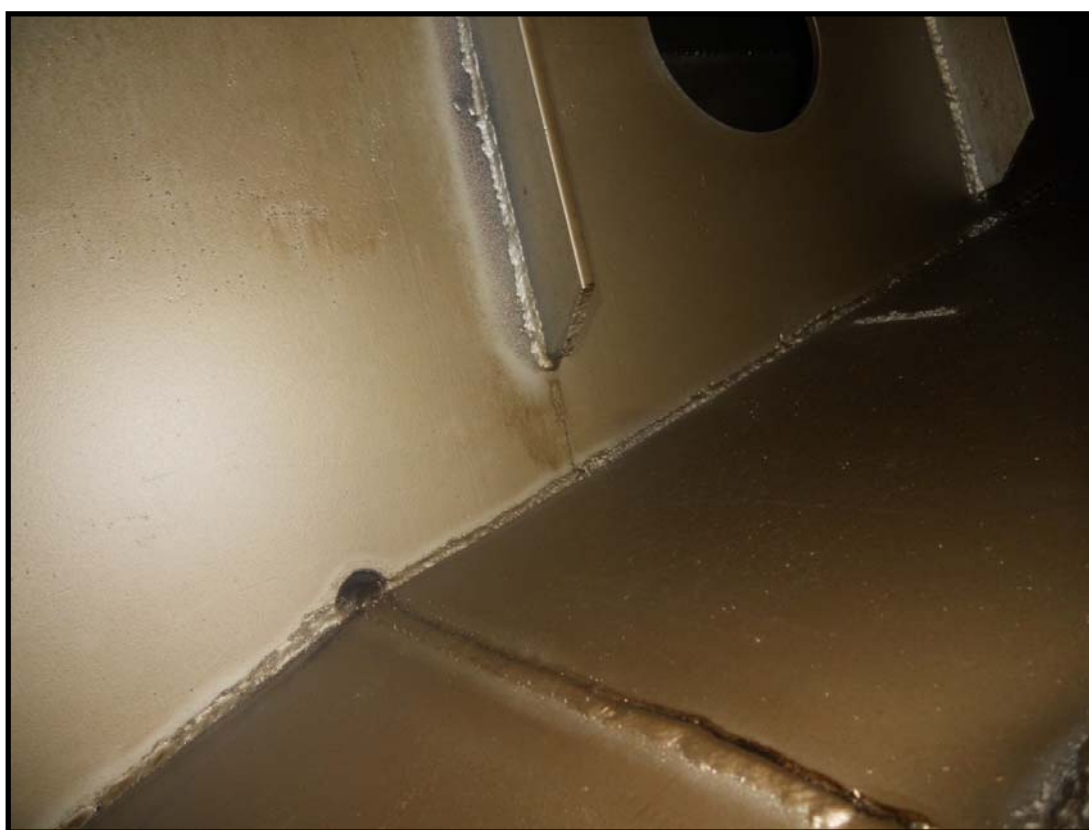
**Figure 19. Fracture-Fair Condition**

Fracture on shell frame inside a side tank

Fracture of web frame inside the topside tank

Weld fractures –Fractures on flanges of brackets, internals, stiffeners-Fractures of Webs of Frames, Floors, brackets, stiffeners and internals- FAIR CONDITION.

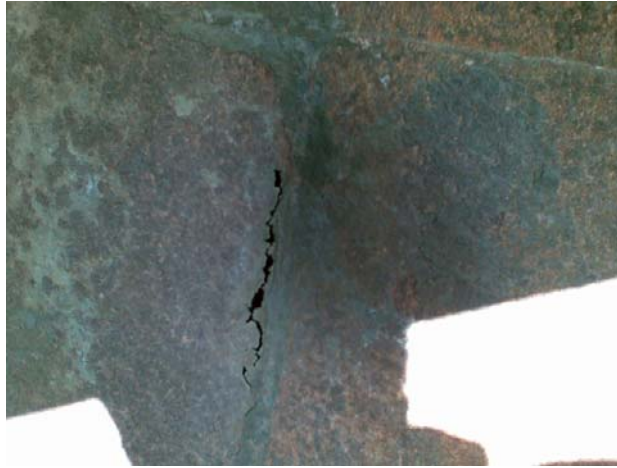
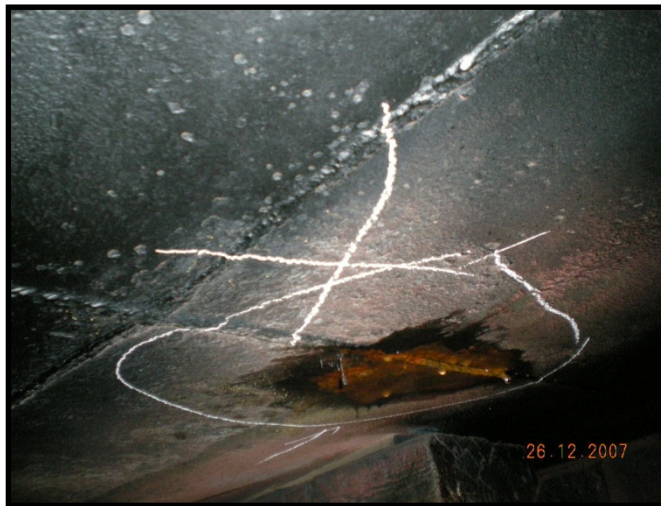
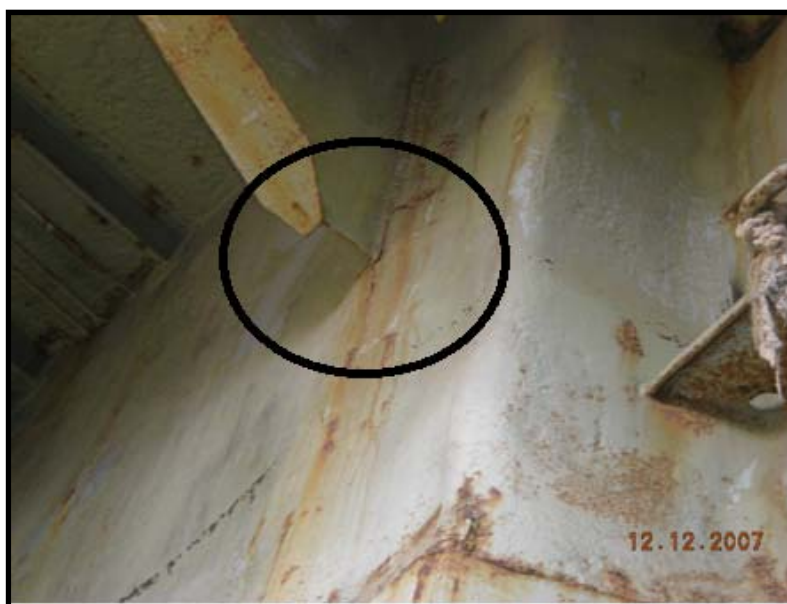
**Figure 20. Fracture-Poor Condition**

Fracture of weld joint on main deck

Fracture on bottom plating

Fracture on transverse watertight hold bulkhead

Fractures on Transverse&Longitudinal Bulkheads, Primary Structural members and Side shell, Bottom Plating and Deck are considered as POOR CONDITION.

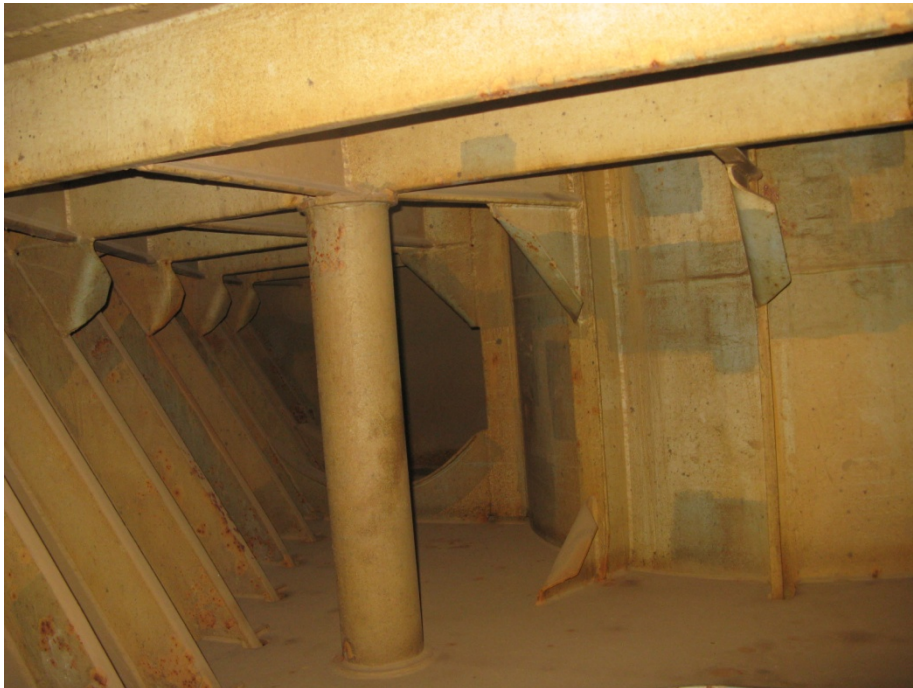
**Figure 21. Cleanliness and Inspection Safety-Good Condition**

Space clean-free from sediments/loose scales

Clean spaces-space may be considered as in new-built condition – GOOD CONDITION.

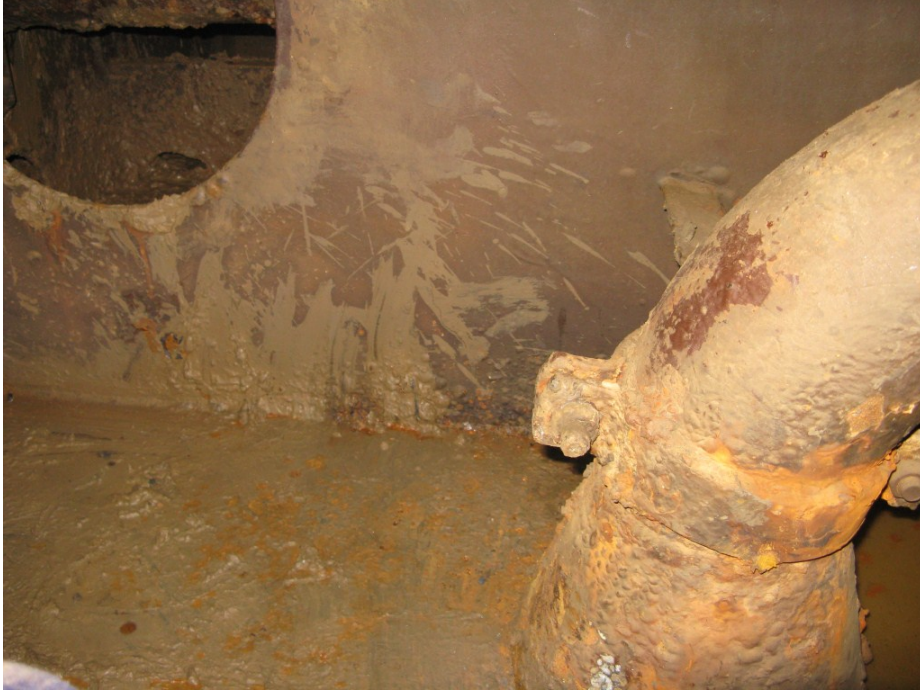
**Figure 22. Cleanliness and Inspection Safety-Fair Condition**

Local cleaning required, small amount of water around the bellmouth

Generally clean, free from excess water-local cleaning may be necessary- FAIR CONDITION.
