# TÜRK LOYDU

## **Guideline on Türk Loydu Hull Inspection and Maintenance Program-Grading for Findings During Inspections**

**2013**

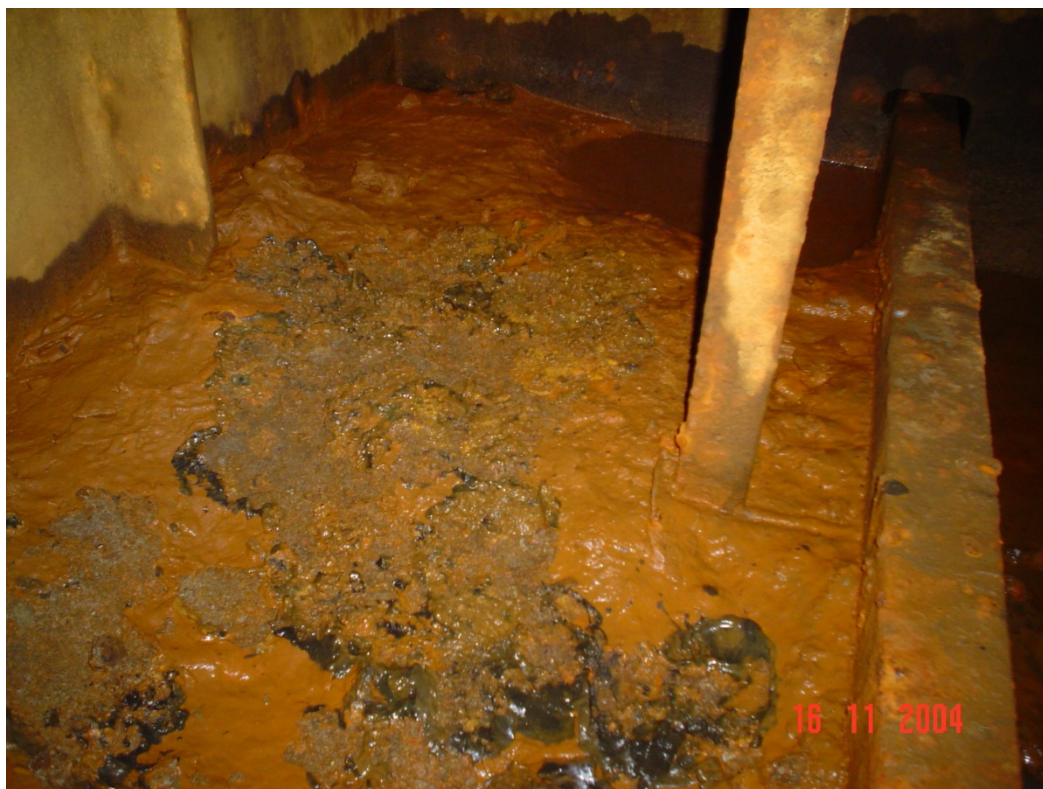
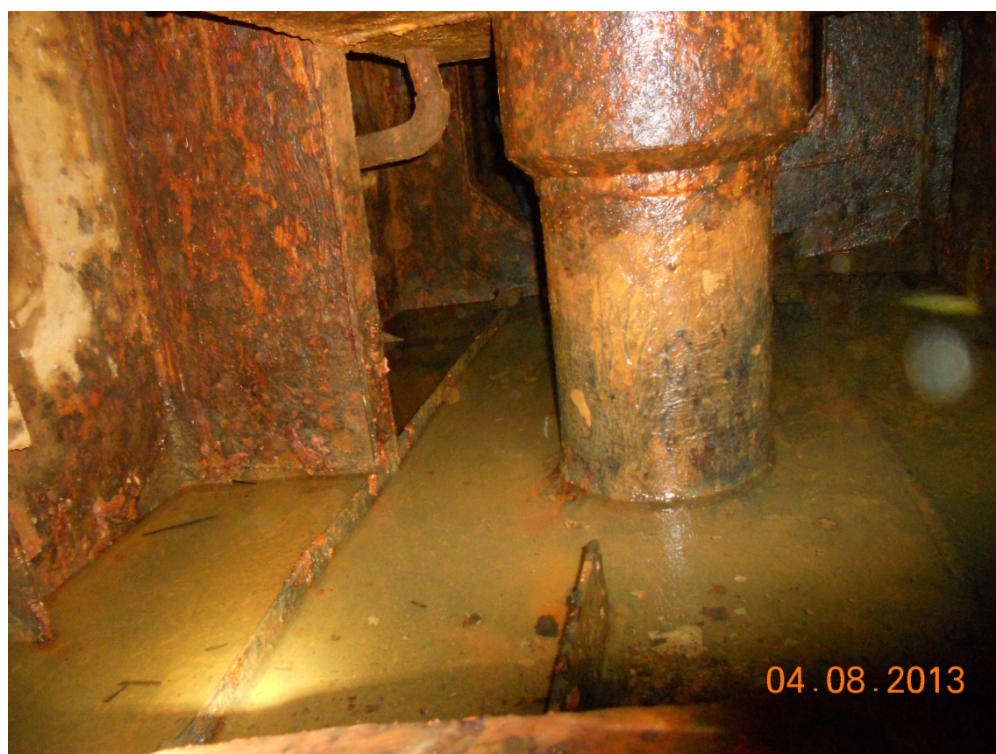
**Figure 23. Cleanliness and Inspection Safety-Poor Condition**

Large amount of sediments and water, bottom plating not visible

No safe access, and meaningful inspection not possible

Spaces with residue, loose scale and sediments-surfaces not visible- POOR CONDITION.

Spaces with means of access-no safe entry-POOR CONDITION.
